# proceq

## Pundit 250 Array Application Booklet

This booklet is intended to illustrate the applications of the Pundit 250 Array instrument. More than that it is intended to be a vehicle that will allow Pundit 250 Array users to share and build their knowledge. This booklet will be updated on a regular basis. If you as a user, have a successful application example that would be of interest to other users or you wish to test a new application, please contact Proceq.

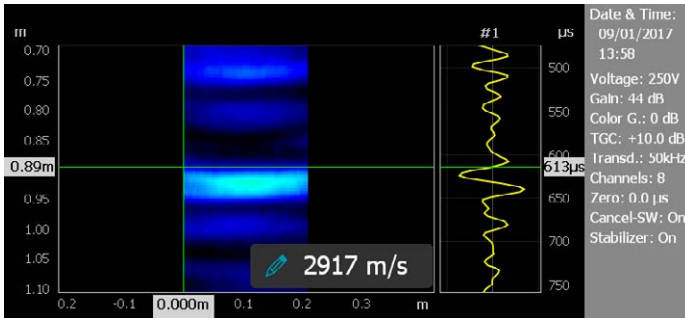
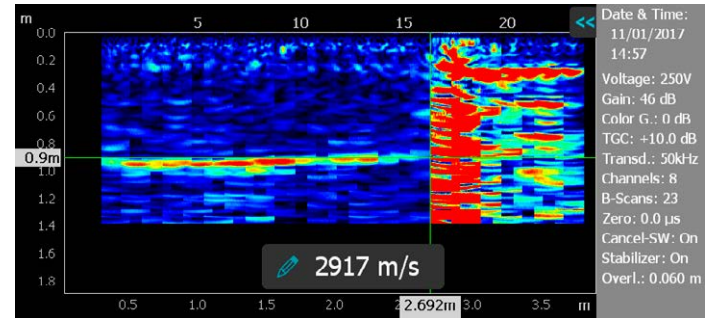
The can above shows a B-scan at the same location after the pulse velocity has been calibrated by measuring at an area of the structure where the thickness is known (Estimate by Echo). The A-scan to the left of the B-scan is used to align the cursor to the beginning of the echo. The difference in pulse velocity from the surface velocity measurement is 227 m/s which resulted in a measured thickness error of about 7 cm or 8% in this case. This illustrates the importance of pulse velocity calibration if accurate depth information is required. The gain has also been optimized to give a clear back wall signal. These settings can then be used to generate a wide area scan using the panorama B-scan.

This is a scan of around 3.5 m. It consists of 23 separate B-scans stitched together. The overlap is set to 6 cm which is equivalent to two channels. It took less than 2 minutes to generate this scan. After 2.7 m from the beginning of the scan there is a step change in the wall thickness. From here on there are multiple back wall reflections due to the short path length.

The scans above had a relatively high gain and high TGC. This was necessary in order to achieve a strong back wall echo at a depth of 90 cm.

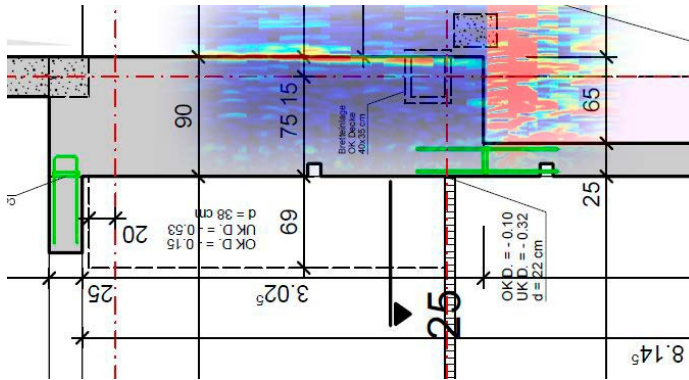
The image below shows how this scan relates to the construction drawings. The wall thickness variations are mapped very accurately.

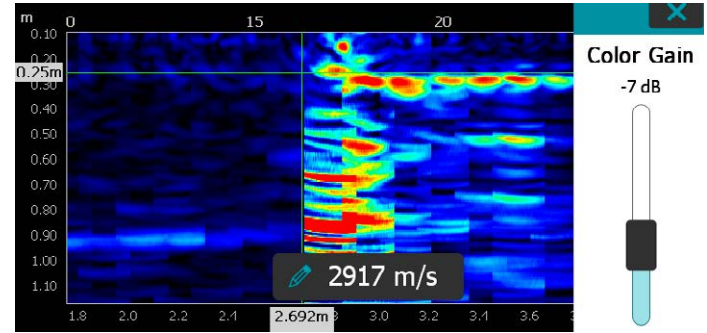
Once a panorama B-scan has been started, it is not possible to change the gain. This can lead to saturation when there are significant thickness changes as we have seen. If we zoom in to the right hand side of the scan where the wall thickness is 25 cm, we can reduce the colour gain to optimize the image in this section during analysis.

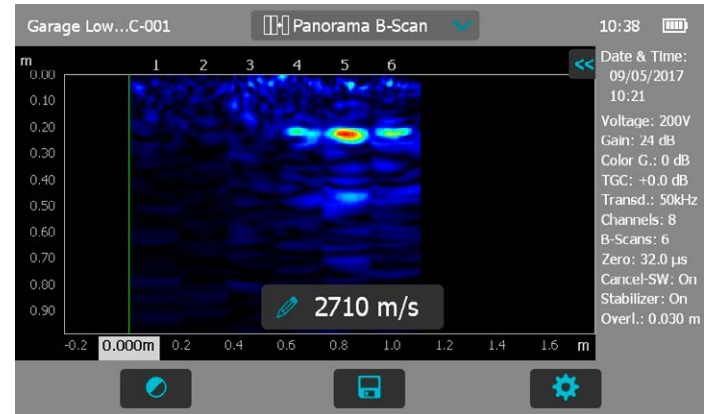
The image below is of the same section of the scan, but with the gain optimized for the 25 cm section. In this case TGC is set to zero. However, with this setting the back-wall reflection at 90 cm is not visible.

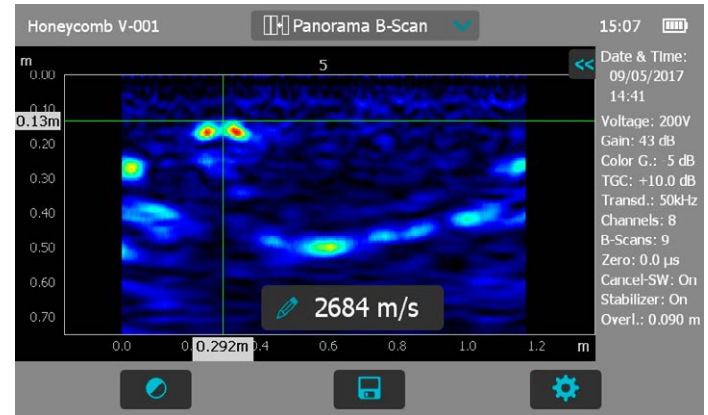
The scan of this test block can be seen here. The thickness variation of the back wall can be traced easily. The honeycombing is loose in this case and can clearly be seen at a depth of 13 cm as indicated by the cross hairs.

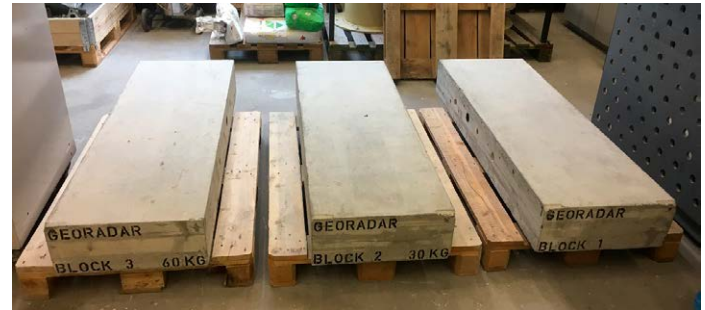
The test blocks shown below are identical except for varying steel fibre content. Test block 1 was constructed with standard concrete with no fibre content. Test block 2 had a fibre content of 30 kg/m<sup>3</sup> and test block 3 had a content of 60 kg/m<sup>3</sup>. Dramix steel fibres 1 x 50 mm were used. The concrete used had a concrete compressive strength class of C25/30 with a maximum aggregate size of 32 mm.

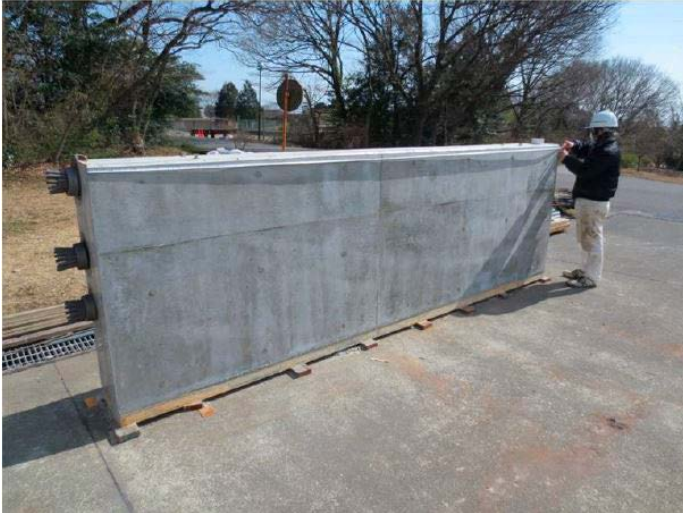
Ultrasonic pulse echo technology can be used to locate tendon ducts and to a certain extent it can be used to investigate the condition of the grouting. Experiments have shown that it is possible to differentiate between the grouted and ungrouted condition by the change in amplitude of the received echoes. The test blocks shown below were created to investigate this.

Rebar spacing: 150 mm  
Specimenthickness: 355 mm  
Rebar size: D13  
Concrete strength: 40N/mm<sup>2</sup>

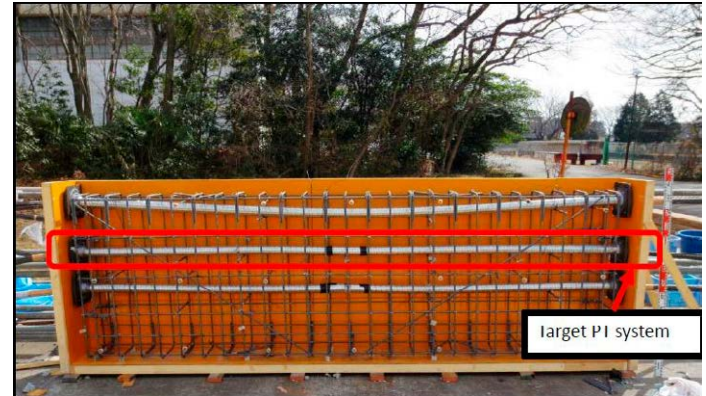
Here we can see the internal structure of the test block. The example is a scan of the middle tendon duct. The details of this PT System:

Stranded wire: (12S12.4 mm)  
Sheath diameter: 70 mm  
Concrete coverage thickness: 220 mm

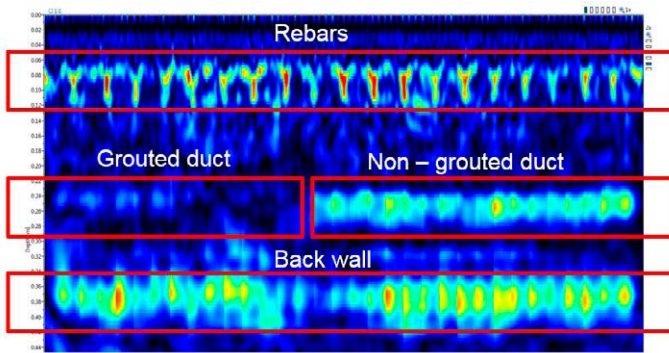
The left hand side of this duct is grouted and the right hand side is not grouted. The scan below shows a span of +/- 1-5 m from the centre.

The back wall echo can be clearly seen at around 35 cm. The rebar grid can be seen at about 7-8 cm.

The PT duct is at a depth of about 25 cm. There are very strong echoes from the PT duct without grout. Where it is fully grouted the echoes are much weaker.
